Centre for Fire Resistance

TE 201767

Two unlatched timber doorsets, as described in this report, were submitted to a fire resistance test in accordance with B.S. 476 : Part 22 : 1987 (Methods 6 and 7) for a duration of 60min.

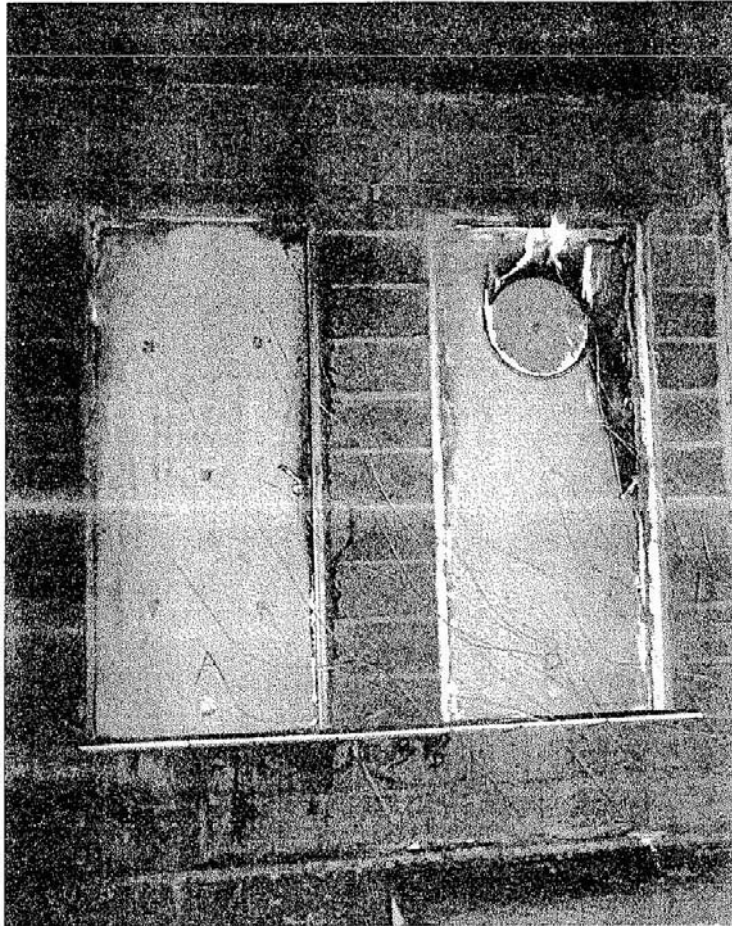
Plate 3 Unexposed face of the two doorsets at end of test

68:00	The window frame on the unexposed face of doorset B ignited.
69:00	Test stopped.

Plate 3 shows the unexposed face of the construction at the end of the test. No photographs of the exposed face were taken as both doorsets extensively burnt away while cooling on the furnace after test.

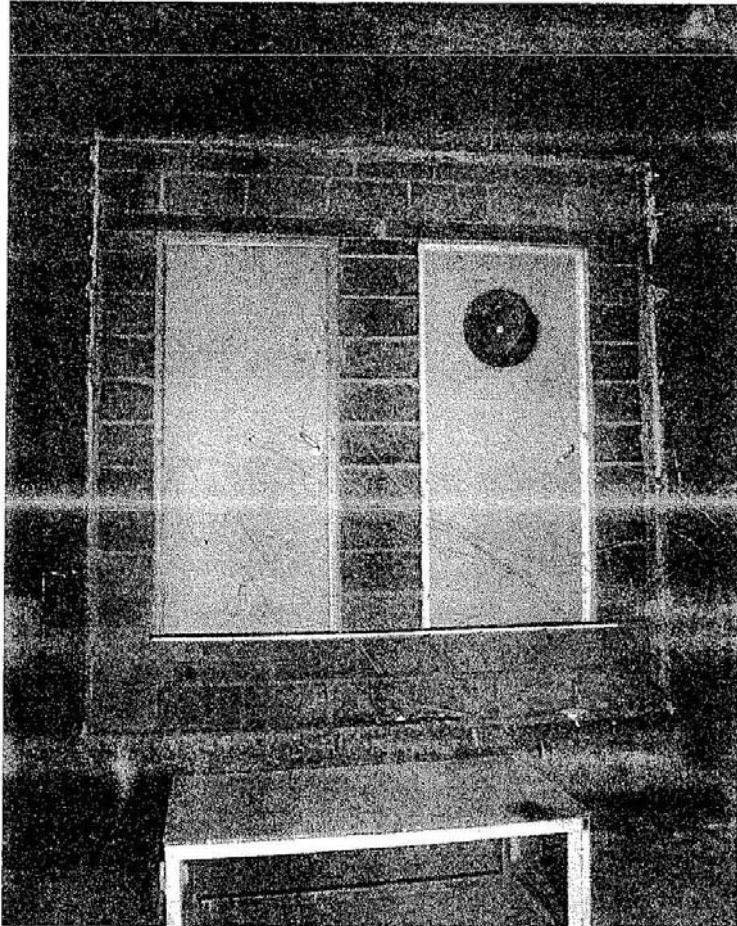
Plate 2 Unexposed face of the two doorsets before test

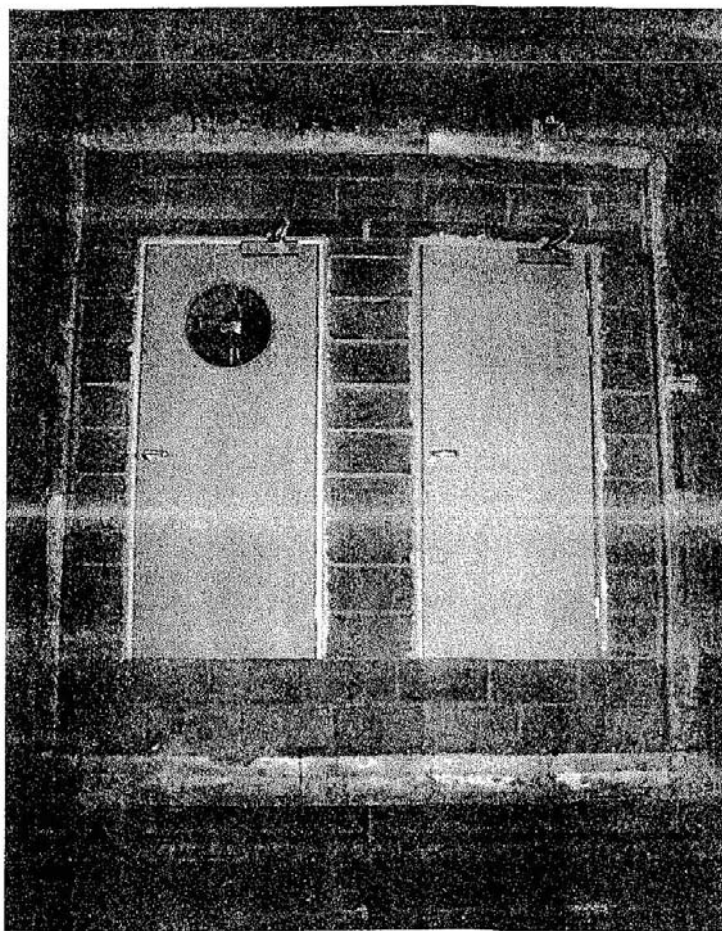
Plate 1 Exposed face of the two doorsets before test

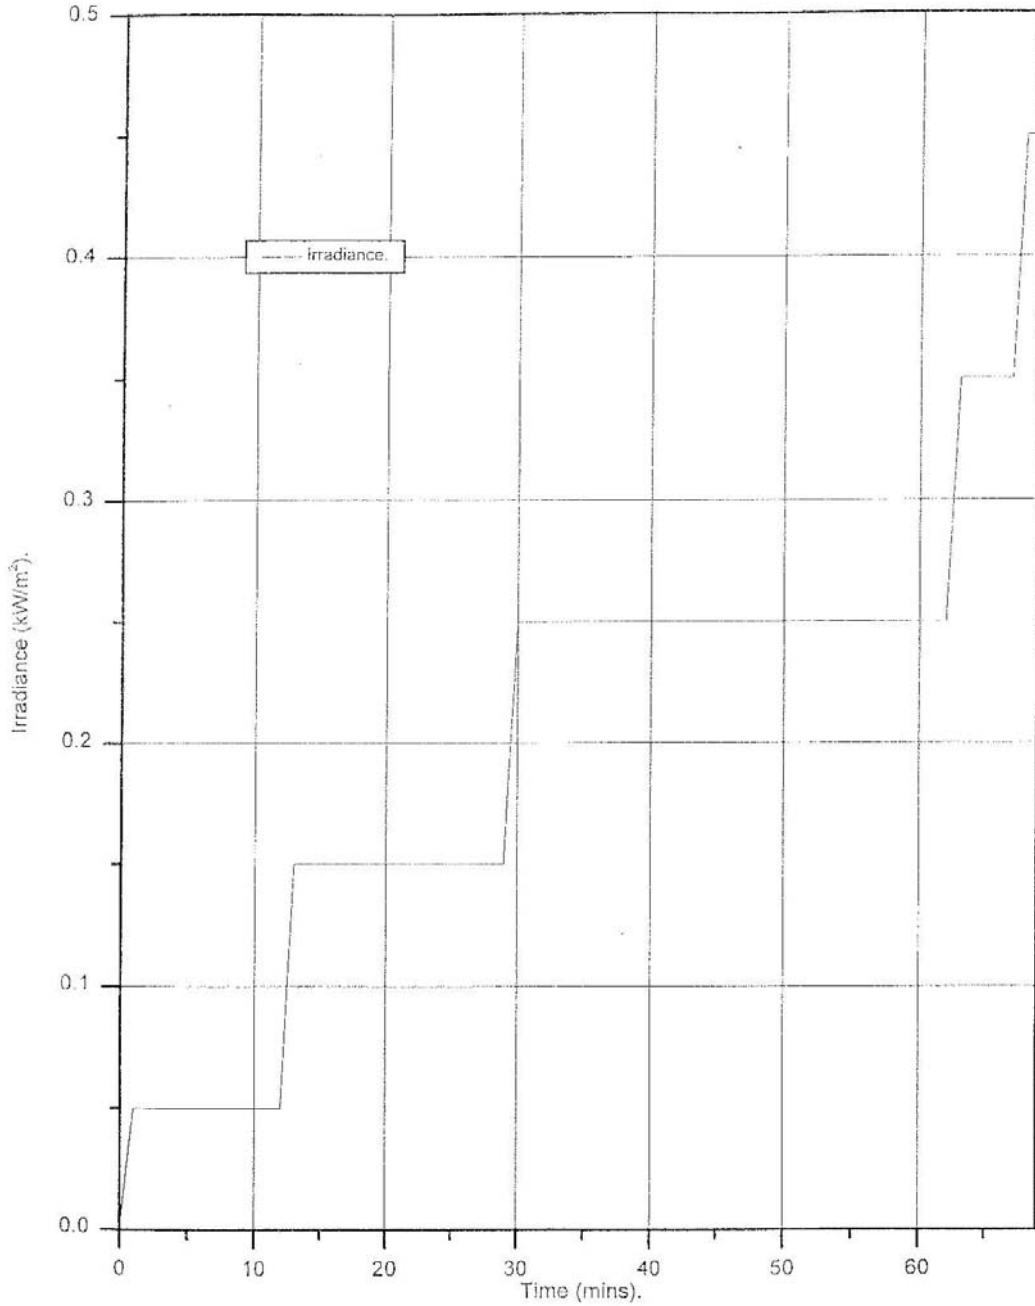
Figure 16 Irradiance recorded from doorset B

The irradiance of doorset B recorded by the radiometer throughout the test is plotted against time in Figure 16. A maximum irradiance of 0.45kW/m<sup>2</sup> was measured after 67mins.

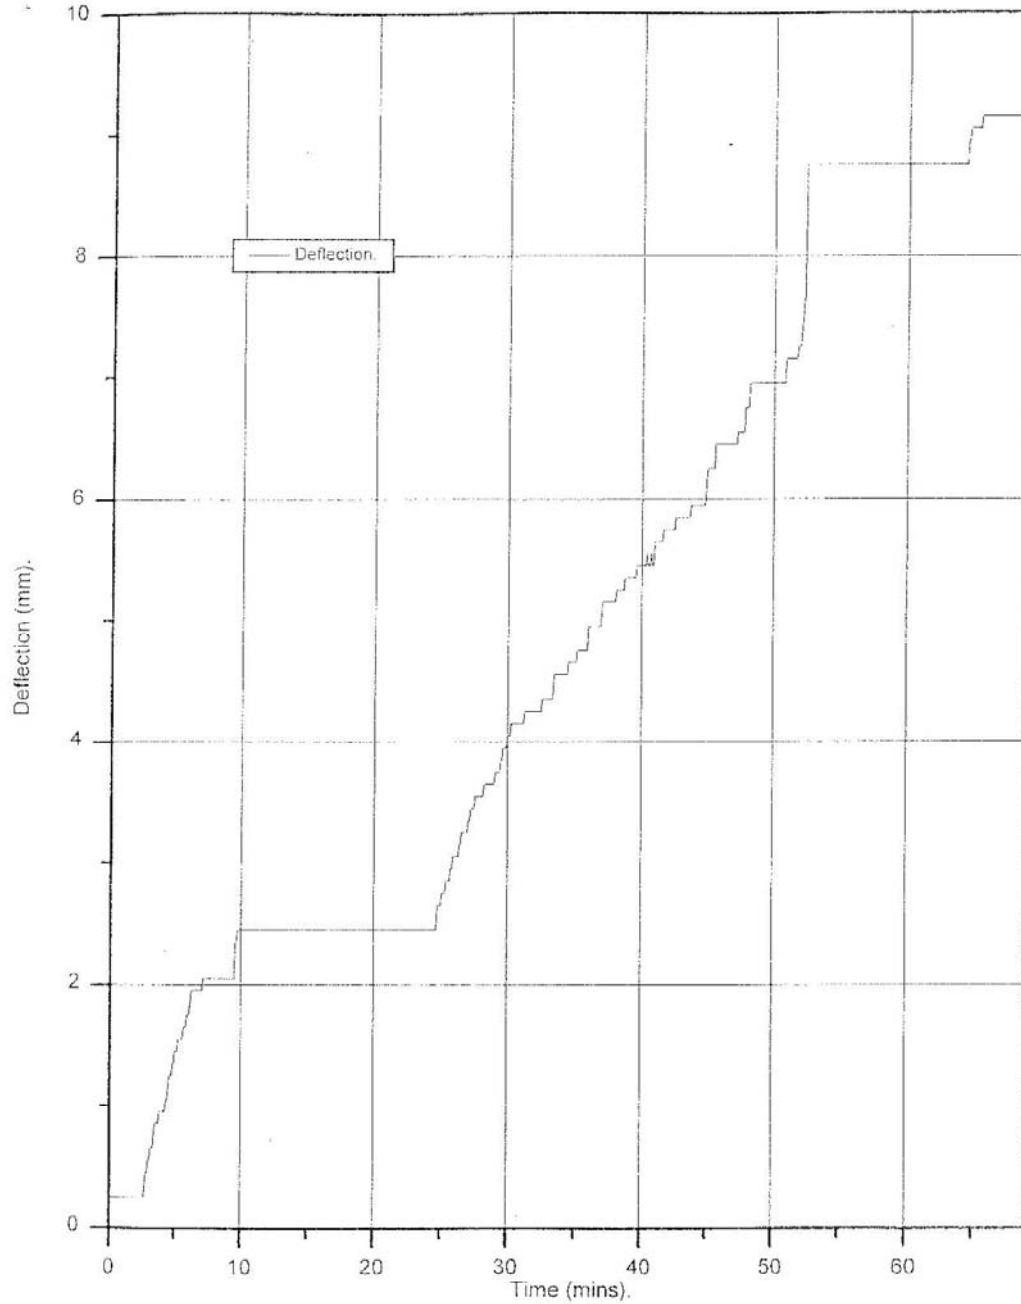
Figure 15 Horizontal deflection recorded from doorset B

The deflection recorded by the transducer for each doorset is plotted against time in Figures 14 and 15. The maximum deflection of each doorset occurred at the point of measurement and was towards the furnace. Doorset A reached a maximum deflection of 4.15mm after 47min of the test and doorset B reached a maximum deflection of 9.15mm at the end of the test.

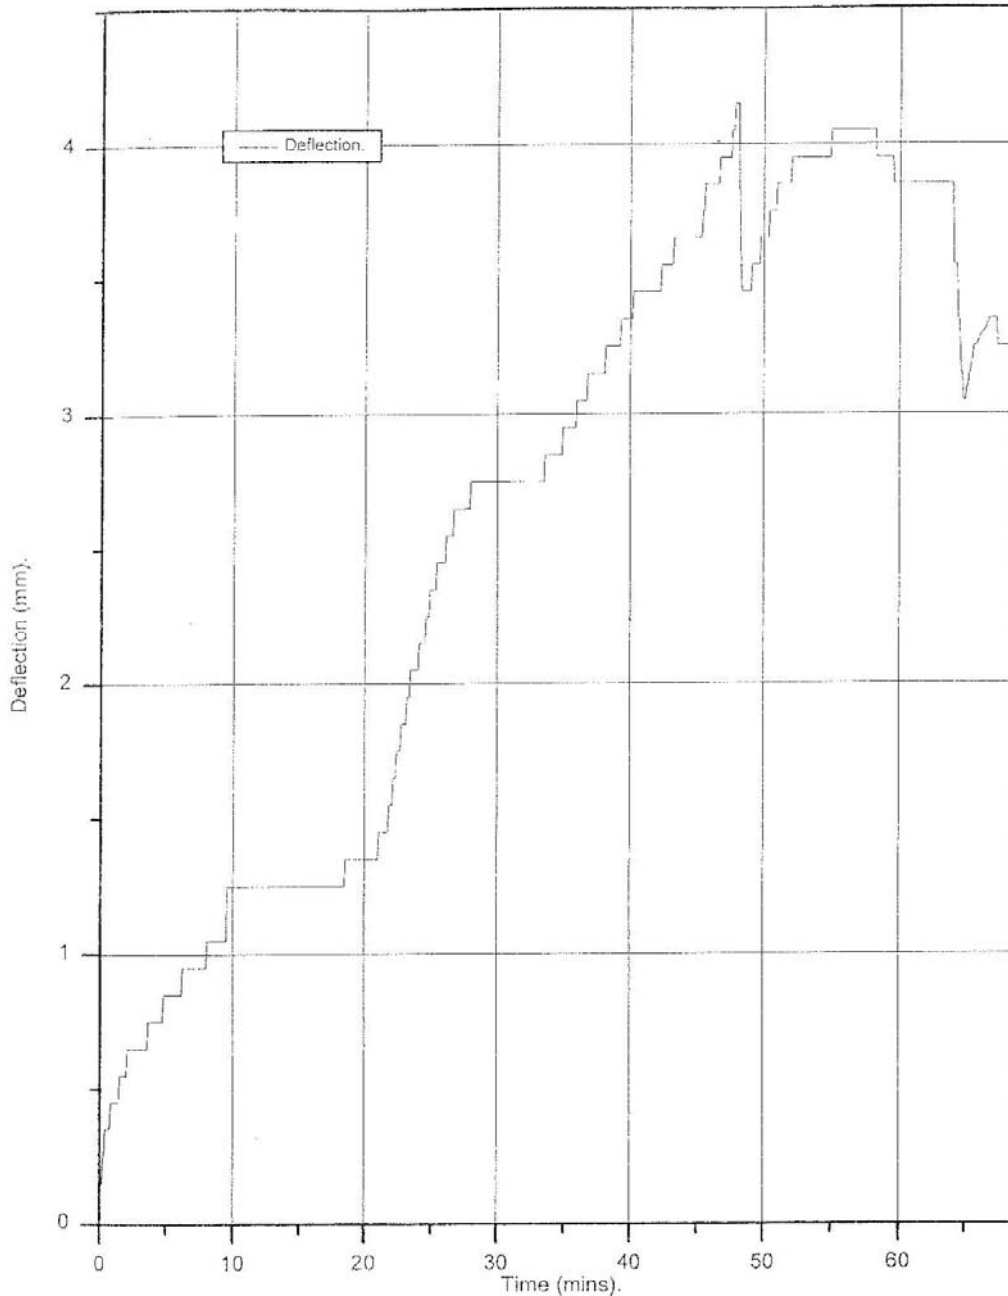
Figure 14 Horizontal deflection recorded from doorset A

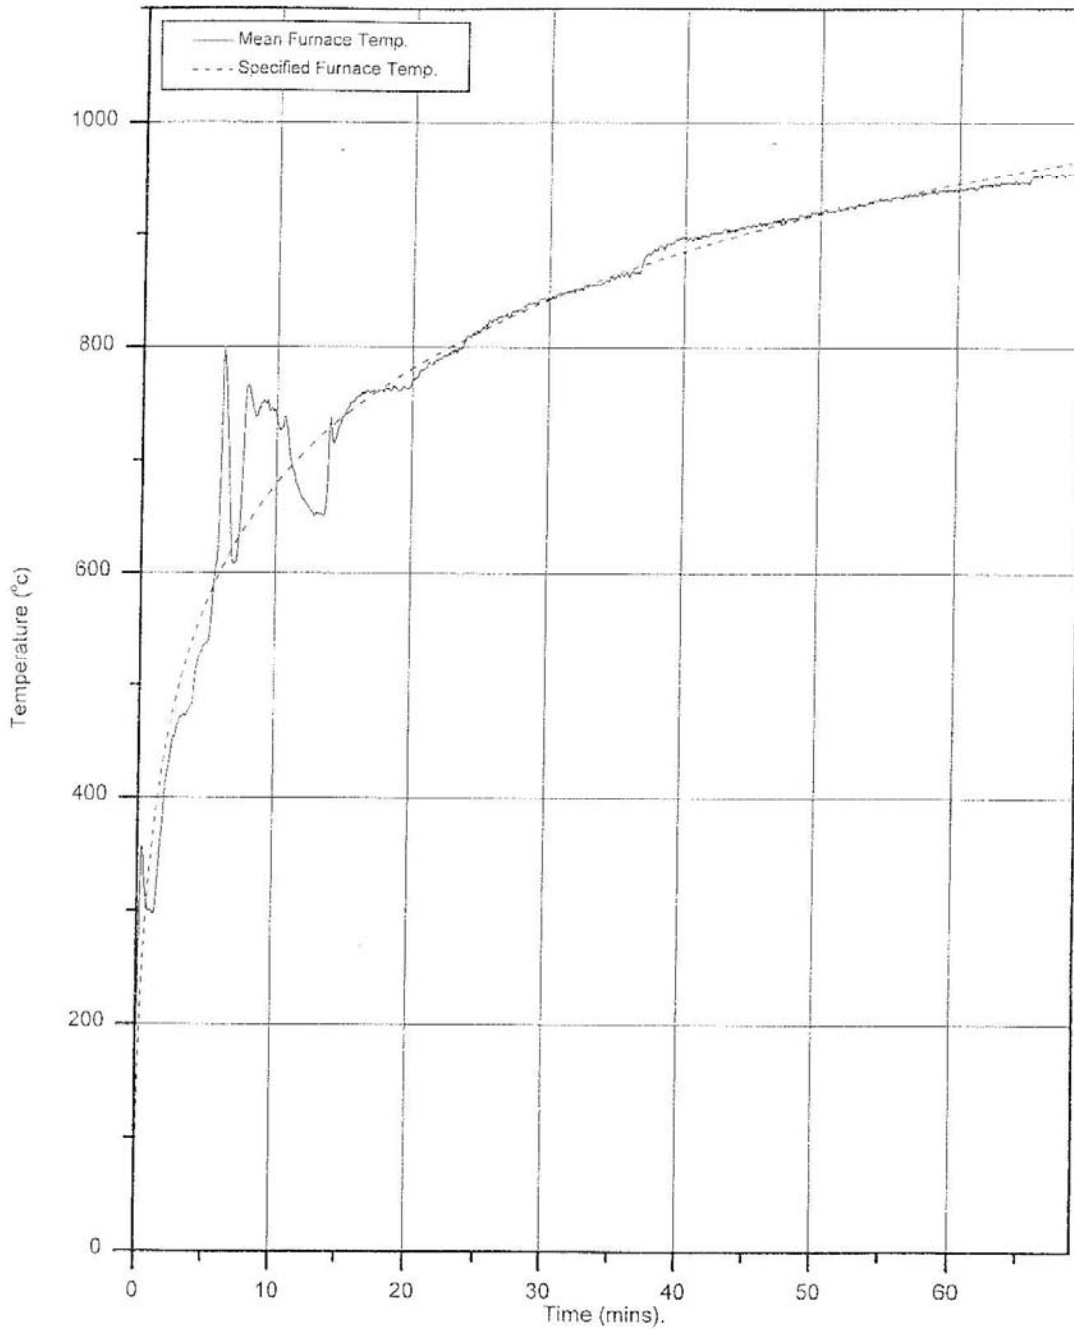
Figure 6 Furnace temperature

The mean furnace temperature recorded is plotted against time in Figure 6 together with the specified curve for comparison.

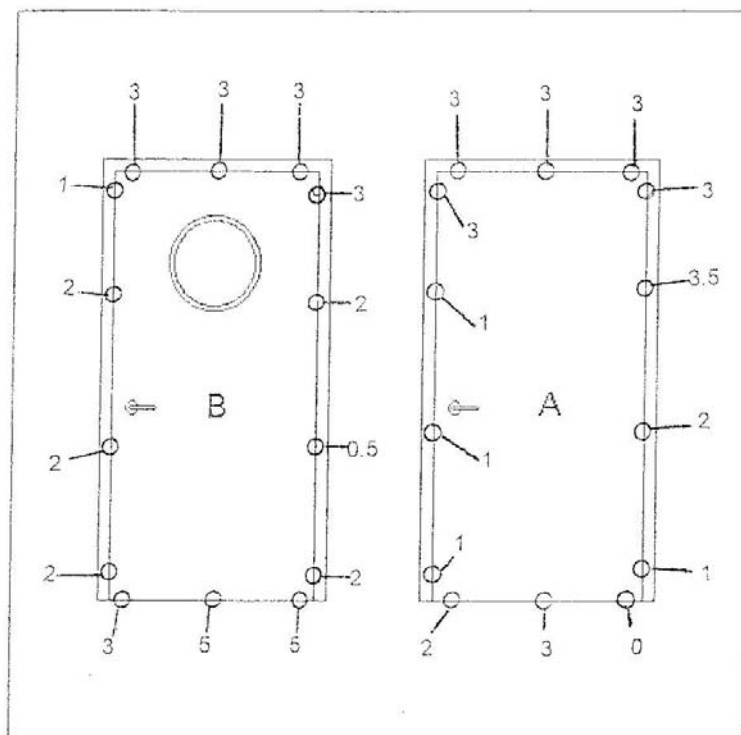
Figure 5 Gap sizes

The width of the gaps between the door leaves and their frames are shown in Figure 5.
